# case study

Historic fuel leak

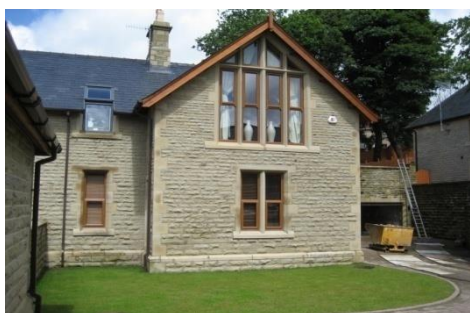
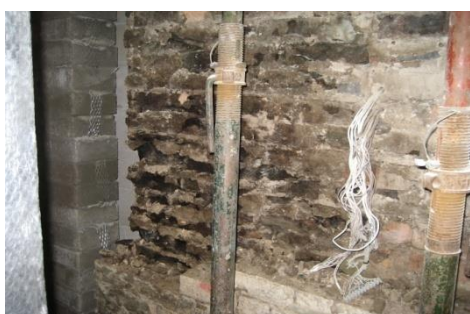
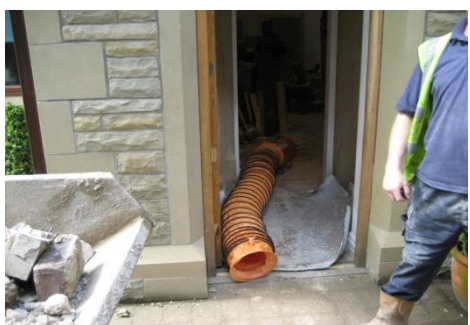
During the redevelopment works the subcontractors failed to recognise oil staining on one of the walls and placed the dry lining directly onto the wall. Several months after the property had been sold the resident noticed staining of the wall and complained of an 'oil smell'

Historical records were checked and the potential for contamination was identified in the vicinity of the wall in question. An intrusive survey was undertaken and samples identified fuel stained brickwork behind the dry lining.

The dry lining and affected brickwork was removed and replaced with new materials. Confirmatory analysis being undertaken at every stage in the process.
