case study

Residential property, Coalville, Leicestershire

Damaged tank

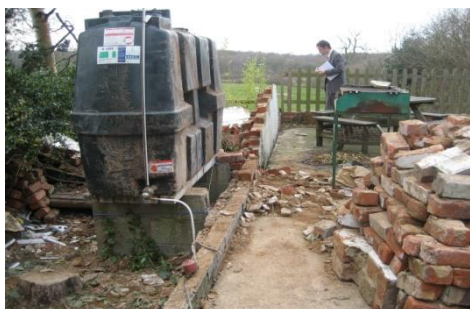
During heavy winds the boundary wall collapsed pushing the adjacent oil tank over. The tank split spilling the fuel across the neighbours garden and decked area.

The site was cleared of all debris and made safe, the contaminated decking was dismantled and disposed off site. A temporary fuel tank was provided and the boiler recommissioned to ensure the residents had heating.
