case study

Residential property, Sterndale, Derbyshire

Damaged fuel line

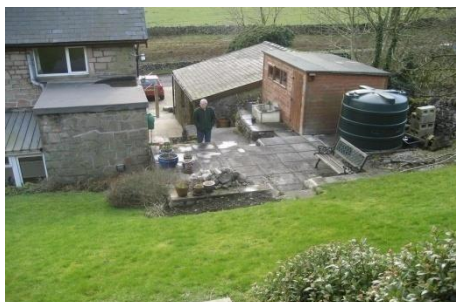
The fuel line feeding the boiler from the external tank corroded causing a substantial loss of fuel below the patio. Fuel had also tracked down the conduit housing the fuel line and pooled behind the wall, soaking the sandstone blocks and causing a vapour problem in the property.

The contaminated sandstone was removed and replaced with new thus alleviating the immediate vapour problem. Gross contamination was removed using absorbent materials and where possible the surfaces were cleaned using chemical cleaners.

Due to the topography of the site, excavation of the grossly impacted soils beneath the patio would have been extremely costly. It was therefore decided to install an automated in situ treatment system.
