case study

Residential property, Coalville, Leicestershire

Damaged tank

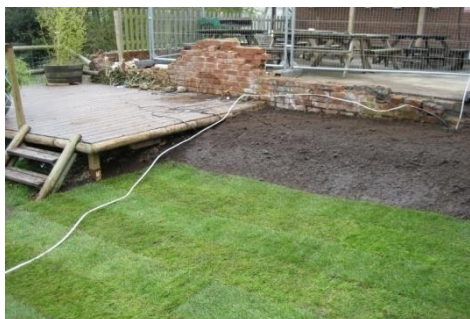
During heavy winds the boundary wall collapsed pushing the adjacent oil tank over. The tank split spilling the fuel across the neighbours garden and decked area.

The site was cleared of all debris and made safe, the contaminated decking was dismantled and disposed off site. A temporary fuel tank was provided and the boiler recommissioned to ensure the residents had heating.

The contaminated soils were excavated and removed from site, on site analysis being used to determine the extent of the dig. On completion, samples of the base and sides were taken and submitted to an independent laboratory. On completion the garden and decking were reinstated to the satisfaction of the residents and the wall rebuilt.
