case study

Damaged fuel line

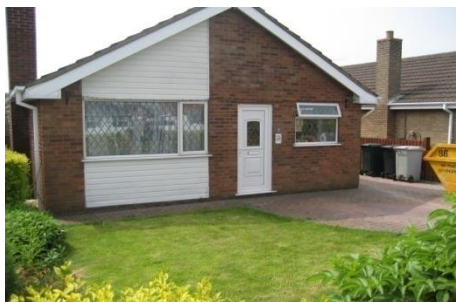
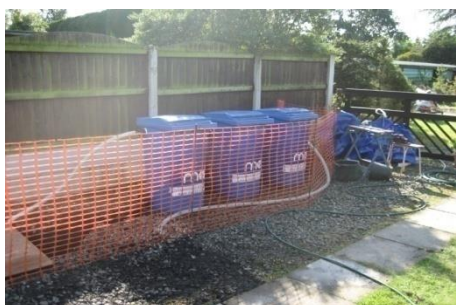
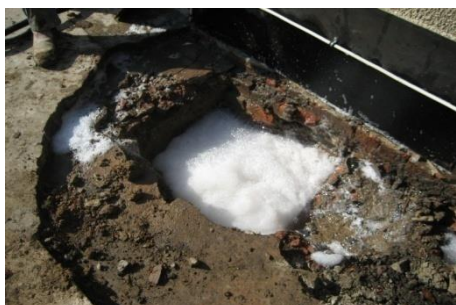
The adjacent property suffered a substantial loss of fuel from the external tank. The fuel seeped down to the near surface water table and migrated onto the neighbours land contaminating a significant portion of the neighbours property.

To minimise further impact whilst the source of the contamination was being removed, a hydraulic cut off system comprising a collection trench and automated pumping system was installed along the site boundary.

The extracted water was treated using one of MEL's proprietary water treatment systems. These systems have been specifically designed for use on residential properties. Once the source contamination was removed at the adjoining property the contaminated soil was excavated and disposed and the groundwater treated in situ.
