case study

Residential property, St Ives, Cambridgeshire

Damaged fuel line

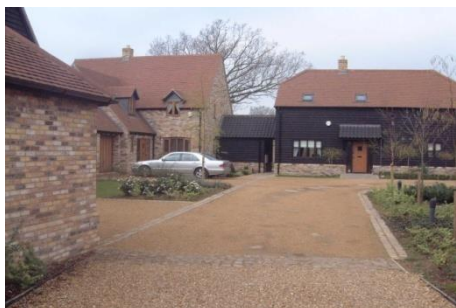
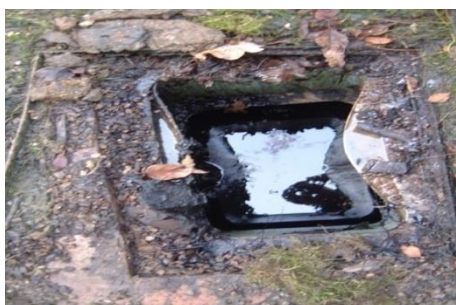
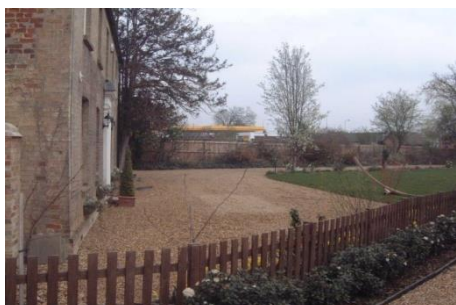
This rural property had an oil fired central heating system. During a delivery of fuel the tanker driver damaged the manhole containing the fuel feed line to the property. The feed line was ruptured and approximately 1500 ltrs of fuel lost to ground.

The fuel moved through the ground adjacent to the fuel line and entered the sub surface of the property causing a significant vapour problem in the building.

The property was vented using a soil air extraction system and where liquid fuel was evident it was removed using vacuum pumps.

Where possible avoiding significant disruption to the property, the soils were excavated and removed off site. Treatment was undertaken below the property using in situ chemical and biological treatment systems.
